SHIFT LINKAGE

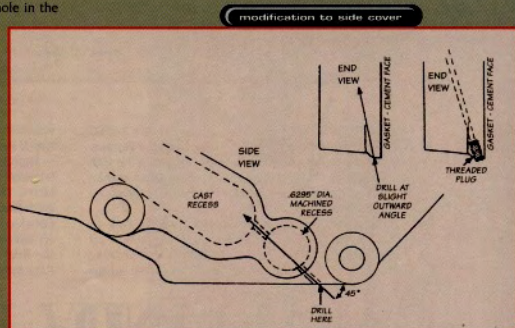
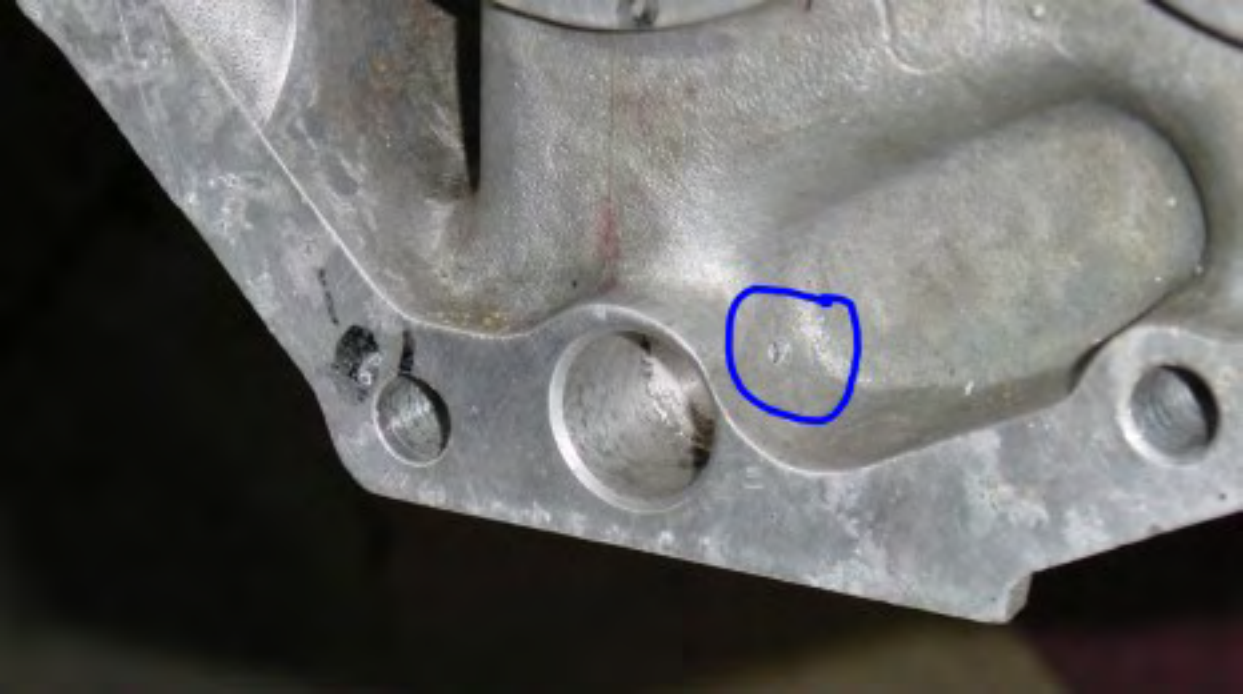
After hours of frustration, coincident with someone turning off the noise of the grinder going next door, we heard a noise best described as "squishing" when the reverse/low rail was moved back and forth. Indeed, upon repeating the action, I suddenly got a small squirt of oil in my eye! This bore more looking into, and here's what we found. When the second/third and fourth/fifth shift rails slide back and forth, the left end of these rails passes through a precision hole in the left side of the transaxle casting and into a recess formed by the side-cover casting. However, when the reverse/low rail moves to the left, it pushes into a machined recess in the side casting, the only escape from which is via the ball-and-spring passage which houses the detent mechanism. Just a few movements of this rail made it evident that the oil, until it became ultra-thin from heating up, was being compressed into this machined recess because there was no relief passage. Likewise for shifting from reverse to low, suction is the cul-

prit. And even the low to second shift is affected because the reverse/low rail institutes the first half of this action. Oil, as you well know, does not compress... period.

The fix is simple and will make your car driveable at all times in all climes. In the illustration, the .6295" diameter machined recess is the culprit. Using the angles shown in both side and end views, drill a tiny pilot hole through the machined recess. Make sure the reverse/low shift rail is away from the end to be drilled. Otherwise, the drill bit will hit the reverse/low shaft. The hole is drilled intentionally off-center so as to line up better with the cast recess. This can be done without removing or even draining your transmission even on a stock 308. Run the drill very slowly and fill the flutes of the drill with white grease. Drilled slowly enough, the cuttings will deposit themselves in the white grease in the flutes, not in the transaxle sump. Periodically withdraw the drill to clean out the flutes and re-grease them. The maximum size of the pressure-relief hole should be smaller than 1/8", so as to allow for tapping to 1/8". You can then seal the bottom of the hole with a small Allen plug. The plug must be coated with a good sealant to prevent leakage. Now, when you make shifts into reverse, low, or the first half of the movement from low to second, the movement of the reverse/low rail is no longer restricted by either compression or suction of oil. No more sticky shifts... ever! This should be a factory fix.
